DOCKYARD PORT OF PLYMOUTH

HAZMAN HAZARD RANKED RISK ASSESSMENT

JULY 2019

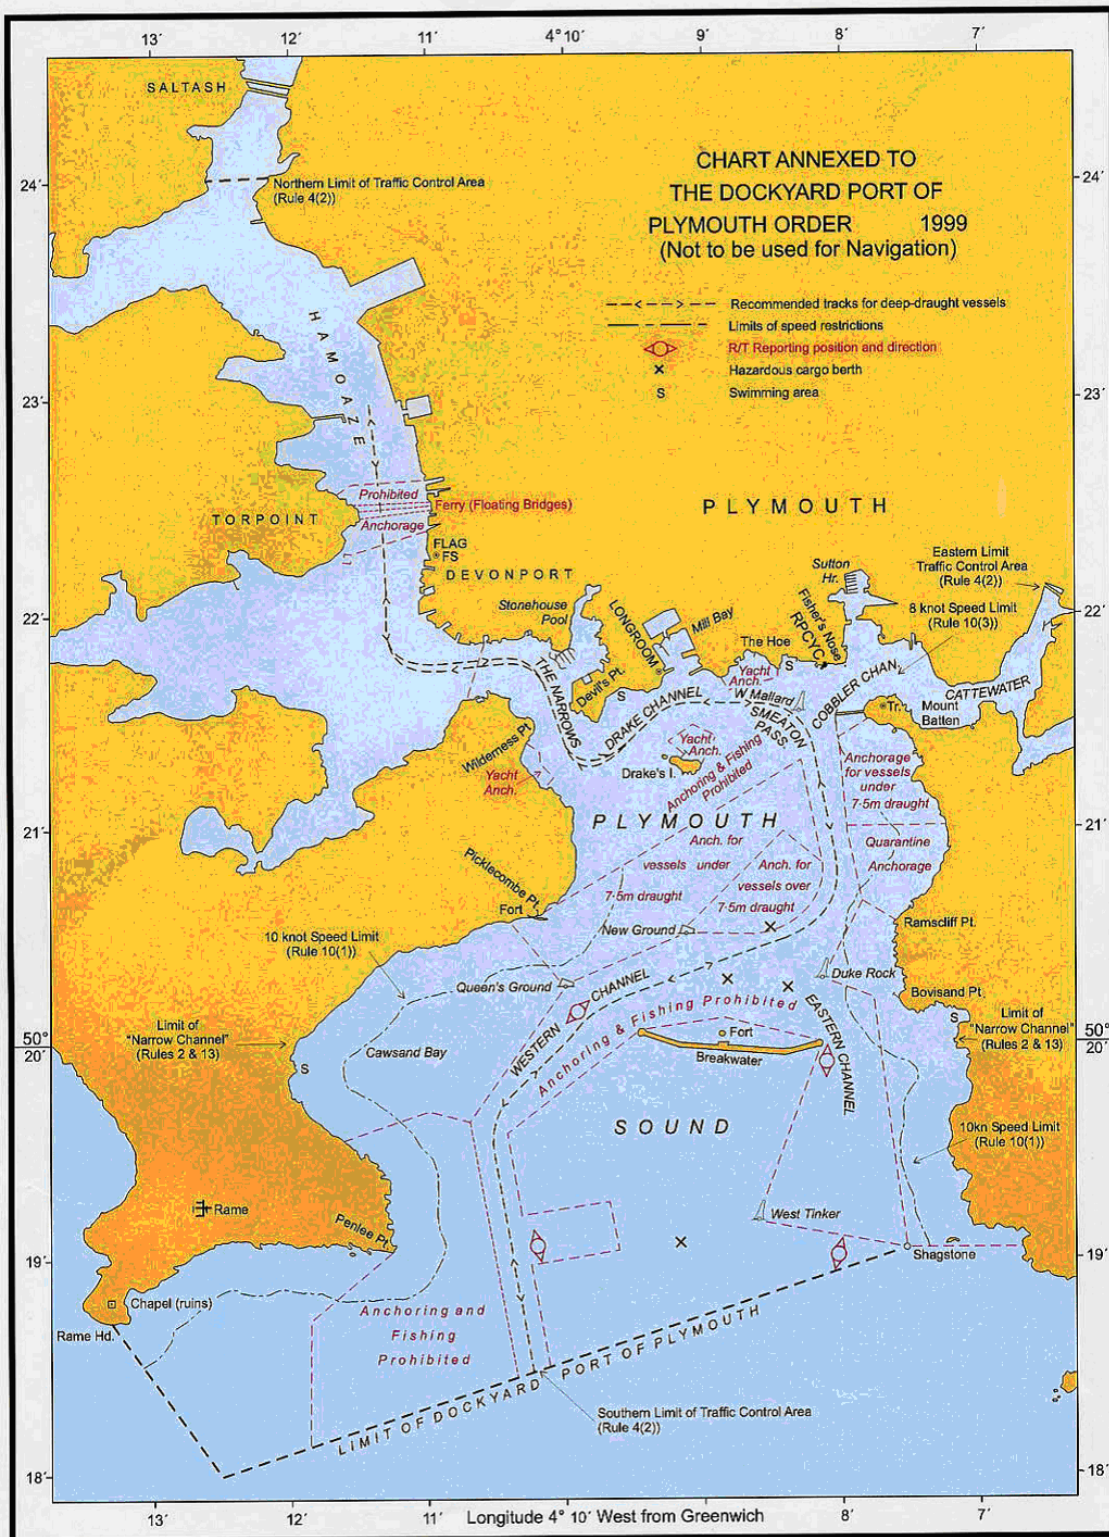
**Figure 1: Limit of Dockyard Port of Plymouth
(Reproduced From The Dockyard Port of Plymouth Order 1999 © Crown
Copyright 1999)**

The purpose of the assessment and reviews is to identify key hazards associated with the operation of ships within the limits of the Dockyard Port of Plymouth (DPoP) as shown on **Figure 1**¹. It should be noted that the Pilotage limits defined by CHC, as Competent Harbour Authority (CHA), are set at a radius of 3.5 nautical miles from the lighthouse on Plymouth Breakwater, i.e., approximately one nautical mile south of the limit shown on **Figure 1**.
